# PROPERTY INSPECTION REPORT

*Alta Integrity Home Inspections LLC*

**Date of Inspection: 9/4/26**  
**Year Built: 1981 Size: 1248sqft**  
**Weather: Sunny**

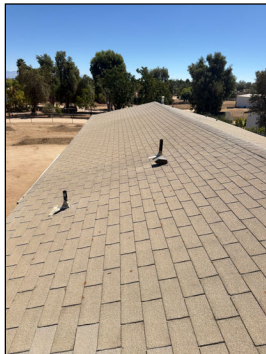
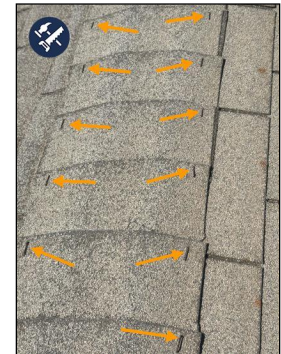
| Page 6 Item: 2 | Roof Condition | • Exposed nails/staples along roof ridge. Recommend sealing all fastener heads to prevent water/moisture entry |

Staples in one or more shingles not sealed

Line shown to display staple areas of concern

- This inspection is made on the basis of what is visible and accessible on the day of inspection and is not a warranty of the roof system or how long it will be watertight in the future. Many leaks occur only under conditions of prolonged rain, and these conditions may not be present at the time of inspection. Clients are encouraged to ask the current owner about the presence of any roof leaks. We do not inspect for the insurability of the home and roof and whether it meets with your insurance companies underwriting approval. Recommend your insurance company pre-approve the roof and related covered items before closing.
- Exposed nails/staples along roof ridge. Recommend sealing all fastener heads to prevent water/moisture entry

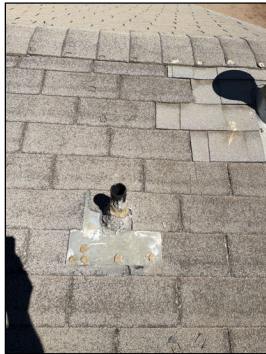
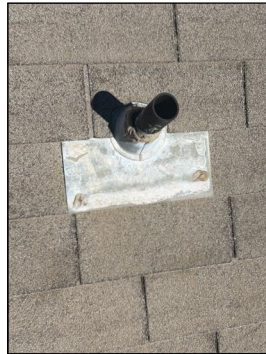
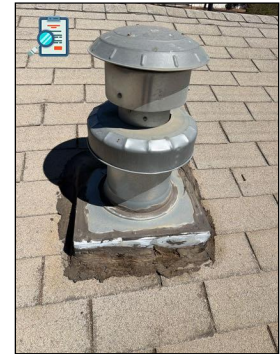
- Vents weather proofing sealant (black tar looking material) showing signs of cracking this is typical wear from the elements recommend resealing as needed

Small gaps in sealant  
recommend reapplying in  
needed areas

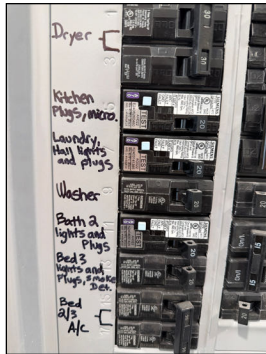
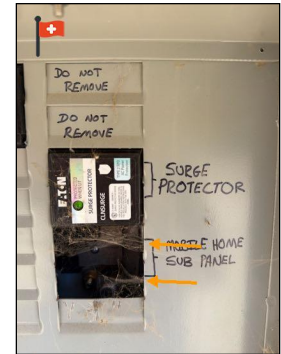
| Page 24 Item: 4 | Wire Type/Breakers | • Open breaker panel slot(s) at panel box cover. Electrocution hazard. |

- Combo breaker AFCI/GFCI
- ---
- Appears Grounded: Yes
- ---
- Surge protection installed: Yes
- Blanks for open spaces (Illustration)
- Open breaker panel slot(s) at panel box cover. Electrocution hazard.

Panel has two open spaces this is a safety hazard

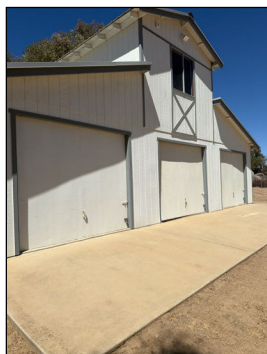
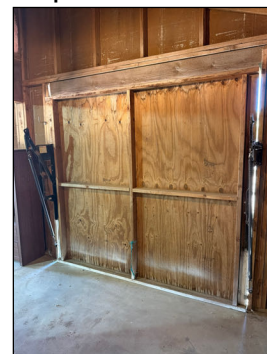
- Doors were locked with pad-lock at the time of the inspection

All garage doors locked were not open

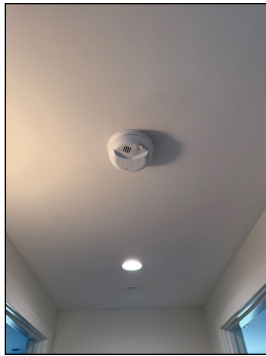
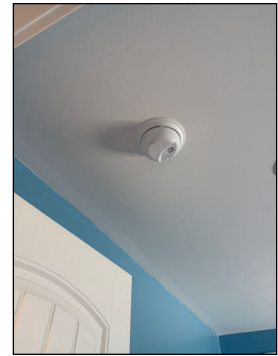
| Page 33 Item: 4 | Smoke/Carbon Monoxide Detector | <ul style="list-style-type: none"> <li>• Carbon monoxide detectors are not present</li> <li>• IMPROVE: There was no visible CO (Carbon Monoxide) detector(s) in the home. The Consumer Product Safety Commission recommends that every residence with fuel-burning (gas) appliances be equipped with a UL Listed CO alarm. CO is colorless and odorless and thus impossible to detect without a proper electronic detector. At a minimum, put an alarm near the sleeping rooms on each level in your home.</li> </ul> |

- **\*\*Smoke Detectors\*\***
- Smoke detectors are present
- Carbon monoxide detectors are not present
- **IMPROVE:** There was no visible CO (Carbon Monoxide) detector(s) in the home. The Consumer Product Safety Commission recommends that every residence with fuel-burning (gas) appliances be equipped with a UL Listed CO alarm. CO is colorless and odorless and thus impossible to detect without a proper electronic detector. At a minimum, put an alarm near the sleeping rooms on each level in your home.

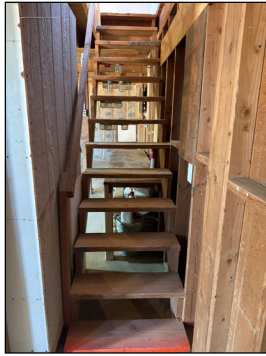
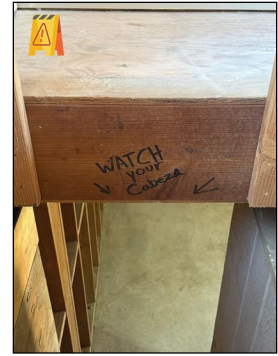
- Location: Garage
- Access: Stairs
- Stairs have a low headroom header mentioned to be aware of and use caution when using stairs

Low Header noted
