# PROPERTY INSPECTION REPORT

*Alta Integrity Home Inspections LLC*

**Date of Inspection: 9/4/26**  
**Year Built: 1981 Size: 1248sqft**  
**Weather: Sunny**

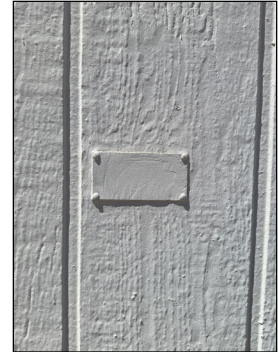
HUD Label (not visible painted over)

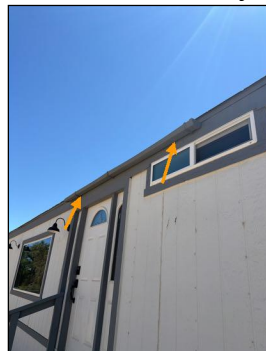
Section of gutter over main entry no defects observed

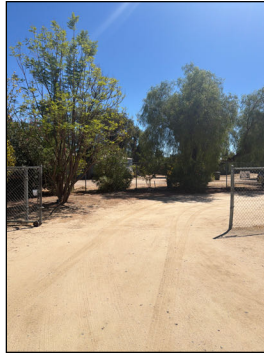
- Fences and gates are not included as part of a home inspection any comments made are for courtesy purposes only
- Driveway gate operated correctly no defect observed

Main Property Entry rolling gate noted

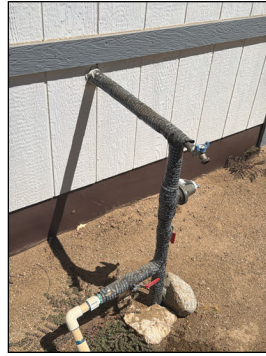
Piping concealed with **PVC** tape

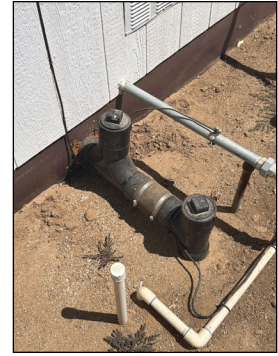
Waste clean out no defects

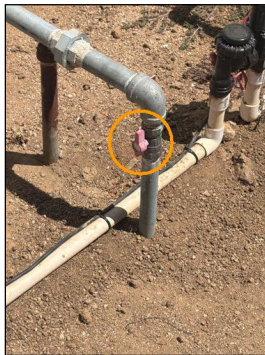
Main Gas Shut off Valve

**Main Gas Valve Condition-** No visible defects or damage noted at the time of inspection

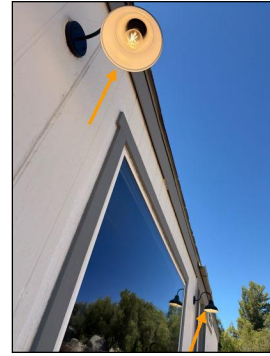
Out door lamps operational

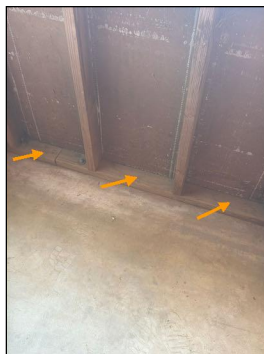
- Wood
- One or more anchor bolt(s) were visually inspected with no visible damage or defects

Wall bottom plate no visible defects

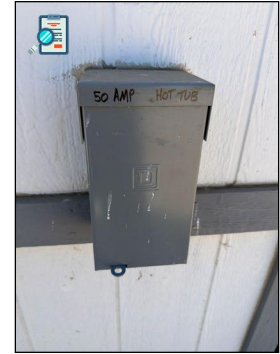
Hot Tub disconnect (recommend asking owner about the panel and its receptacle location for reference)

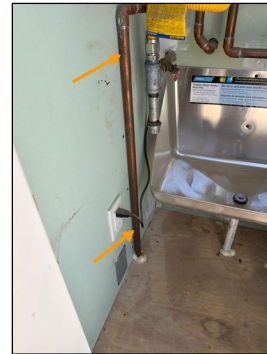
Drain extension pipe no visible defects observed

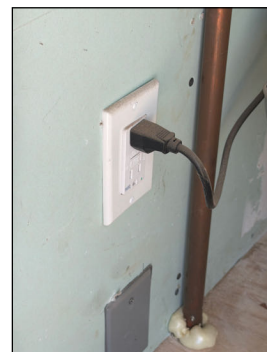
Heater Electrical Disconnect

- Appears functional with no visible defects
- Disconnect: Yes (This is generally the receptacle that the heater is plugged in to that serves as the "Disconnect")

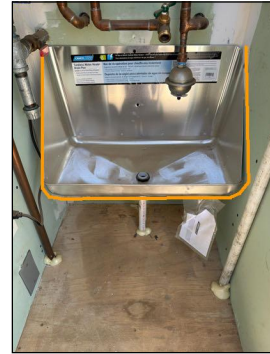
Tankless Drain Pan noted no defects

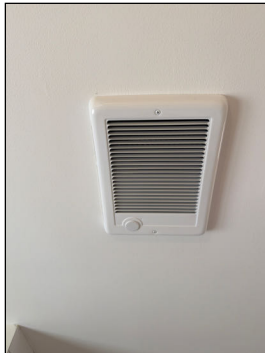
Heater in each bathroom

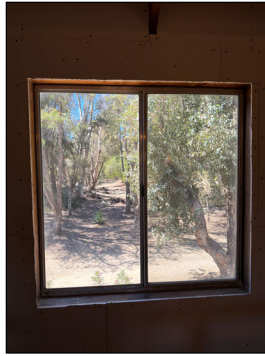
- Window functioning as ventilation noted

Attic Window noted -Aluminum Frame-

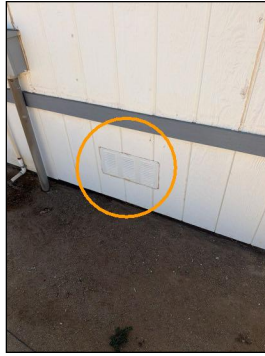
Crawlspace vents located around the perimeter of the home
