# PROPERTY INSPECTION REPORT

*Alta Integrity Home Inspections LLC*

**Date of Inspection: 9/4/26**  
**Year Built: 1981 Size: 1248sqft**  
**Weather: Sunny**

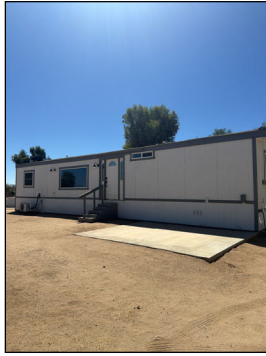
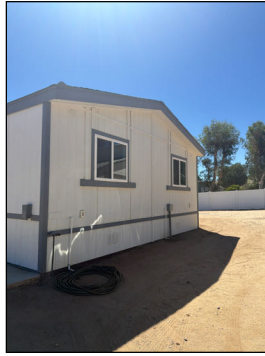
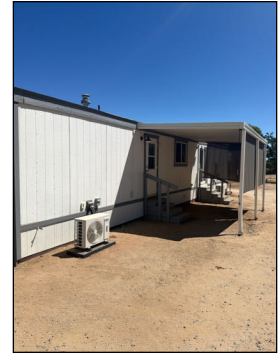
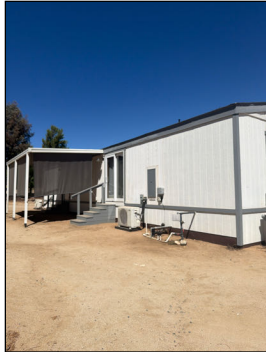
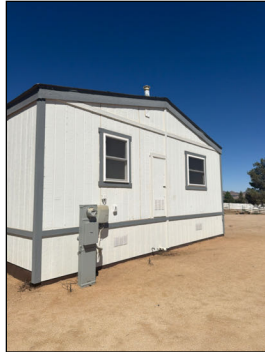
HUD Label (not visible painted over)

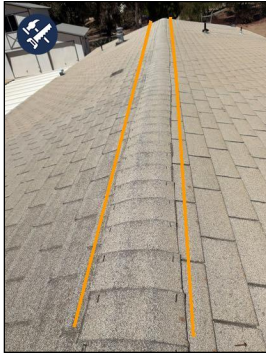
Line shown to display staple areas of concern

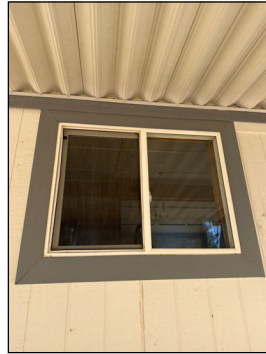
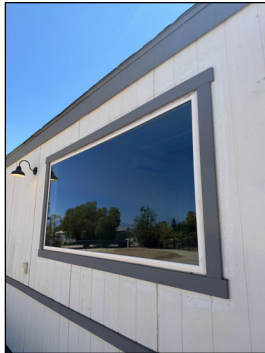
- Vinyl framed sliding window noted.
- All windows tested are in correct working order with no defects at the time of inspections

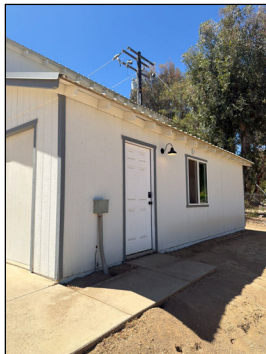
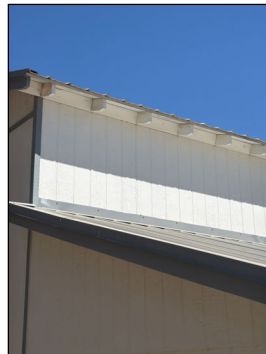
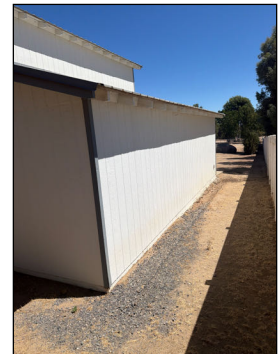
- No major system safety or function concerns noted at time of inspection.

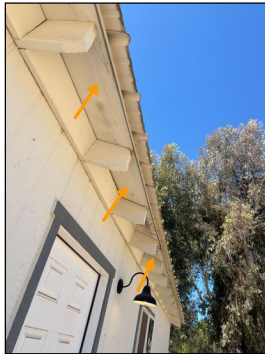
Shown for reference

- Eaves are satisfactory additionally no signs of bird nesting or bee hives at the time of inspection

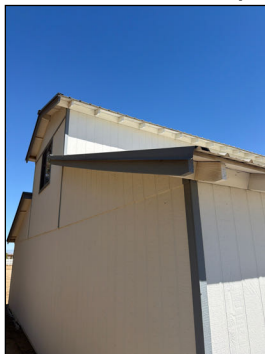
- Fascia of the home/garage has no major areas of concern noted at the time of the inspection

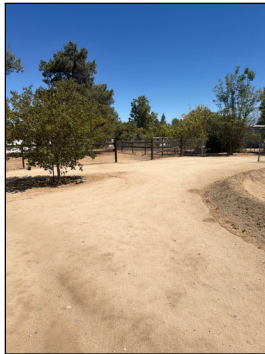
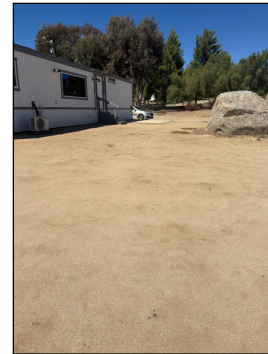
- ---Driveway---
- No major system safety or function concerns noted at time of inspection

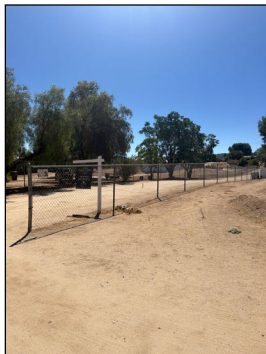
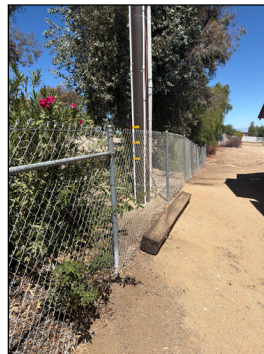
- The fence is excluded from the home inspection. Any comments are made for courtesy purposes only.
- General fencing of the perimeter of the home is in good shape for age and wear.

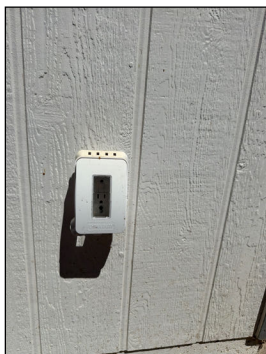
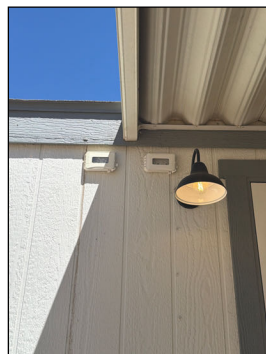
Exterior light and Outdoor receptacle

- Exterior receptacles: Yes
- Exterior receptacles, operable: Yes
- ---
- **GFCI** present: Yes
- GFCI operable: Yes
- ---
- Lights tested operational: Yes

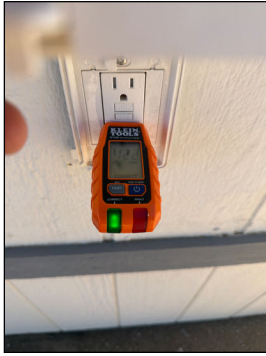
Out door lamps operational

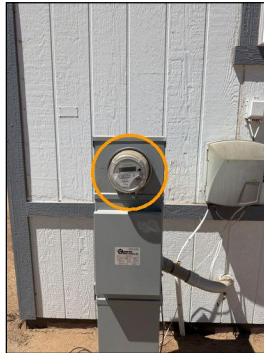
**Conditions-** No visible defects or damage noted at the time of inspection

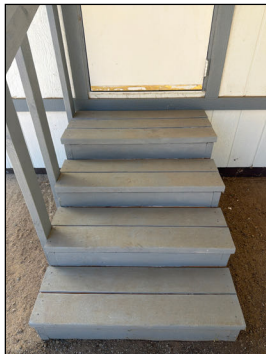
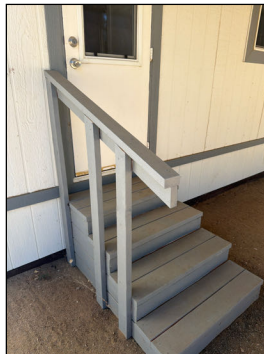
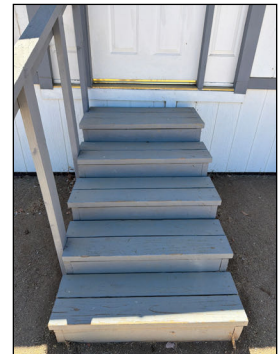
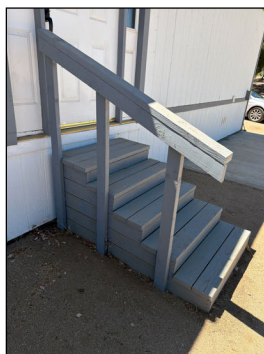
- Steps/rails satisfactory with no noticeable areas of concern at the time of inspection

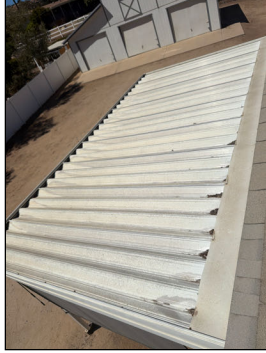
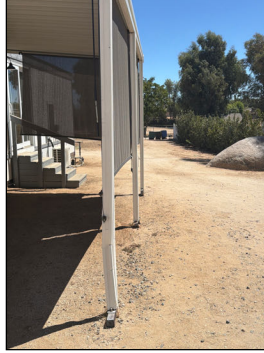
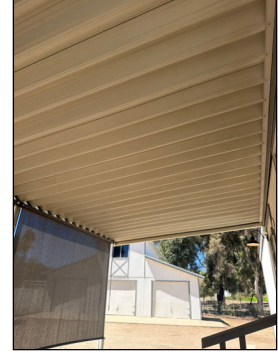
- No major system safety or function concerns noted at time of inspection.

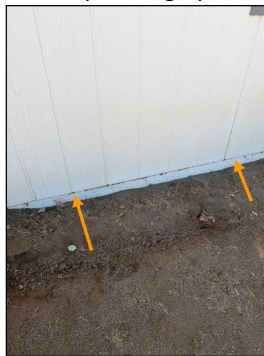
- No visible defects or areas of concern

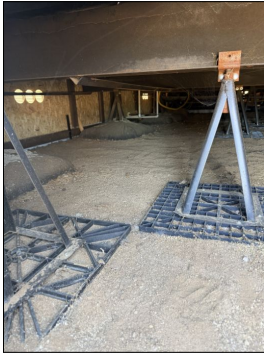
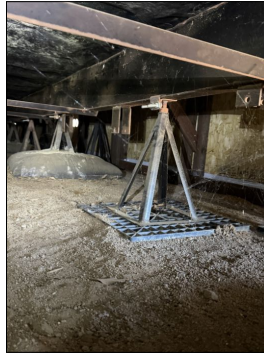
Jackstand(s) & Base Stand(s)  
shown for reference

- Jack Stand and base system as well as seismic support(s) installed with no noticeable defects or damages at the time of inspection
- Support Material: Steel

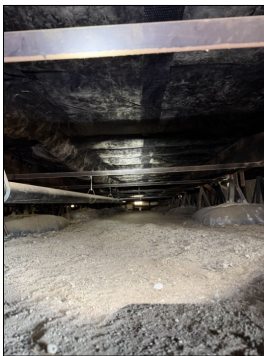
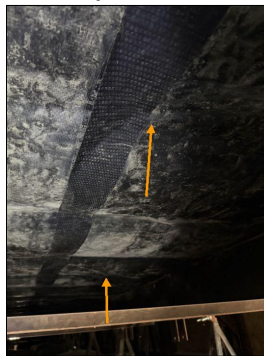
- Joists: No Defects observed
- Subfloor: No visible areas of concern or damages at the time of the inspection
- ---
- Subfloor moisture barrier (black covering) has no observed damage or defects at the time of inspection

Moisture Barrier shown for  
reference

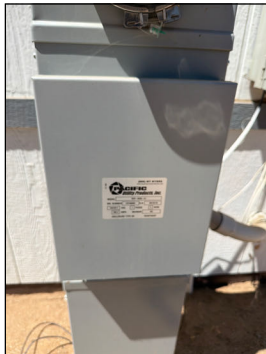
Main Service Disconnect

- No major visible safety concerns noted on all panel(s) at the time of inspection

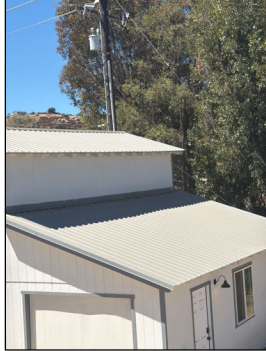
- No visible defects or damages noted at the time of inspection
- Trim trees that are in contact or proximity to home, as branches can abrade roofing or siding.

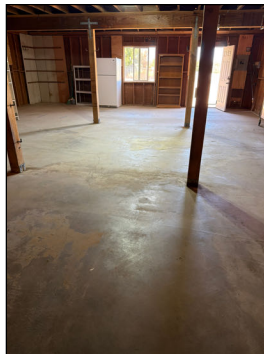
- Floor in good shape for age and wear. No deficiencies noted.

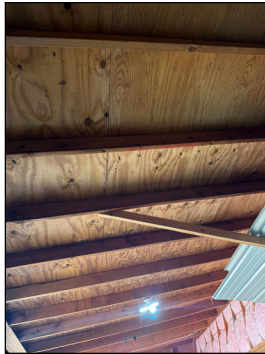
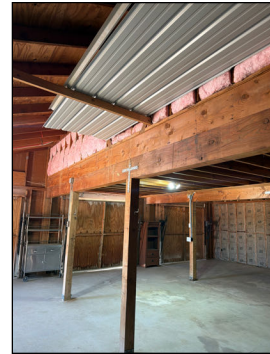
- Moisture stains present: No
- Typical cracks: No
- Open ceiling with no major deficiencies of the roof structure at the time of inspection
- Plywood Sheathing noted.

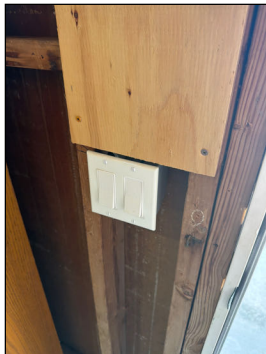
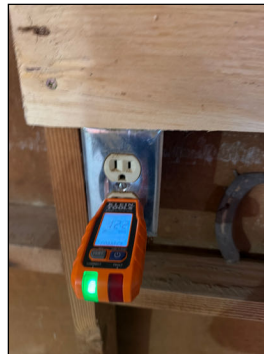
- Electrical: No apparent defects

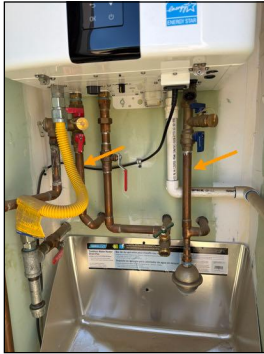
Hot/Cold lines shown for reference

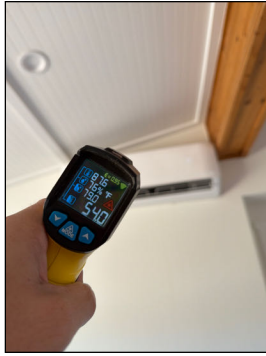
AC Temp 54'

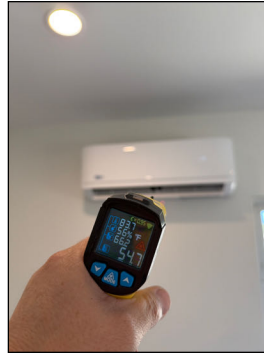
AC Temp 54

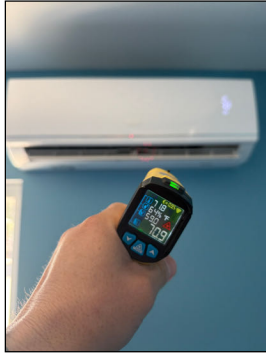
Heater Temp 70'

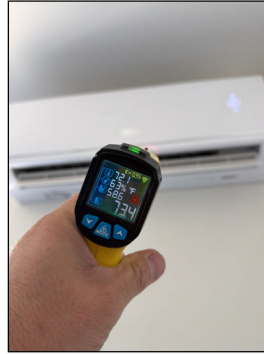
Heater Temp 73

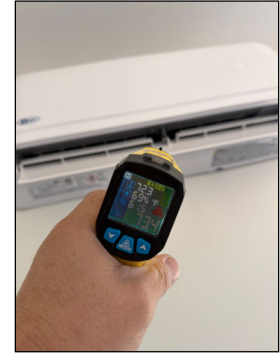
Heater Temp 73

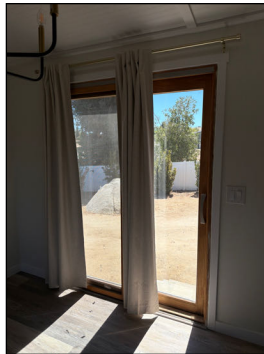
- Wooden sliding patio doors noted
- The door is showing signs of wear older style wooden door

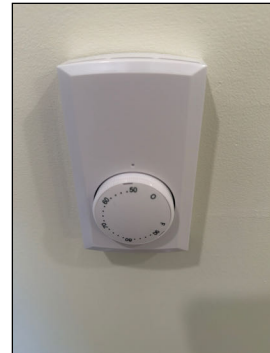
Heater Control in each bathroom

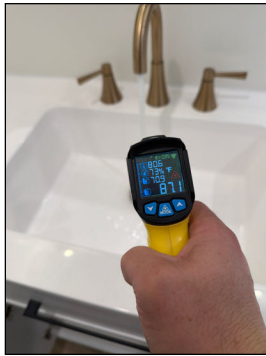
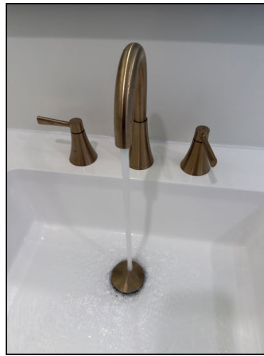
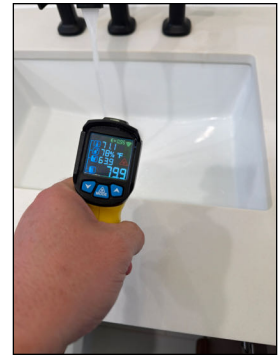
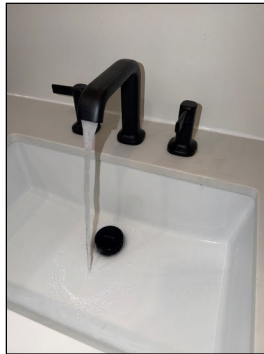
- Sink(s) faucet leaks: No
- Sink(s) pipes leak: No
- Hot water present at all sink fixtures
- See individual photos of random temp checks for digital confirmation

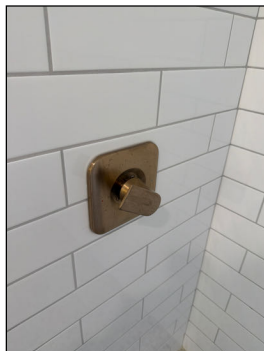
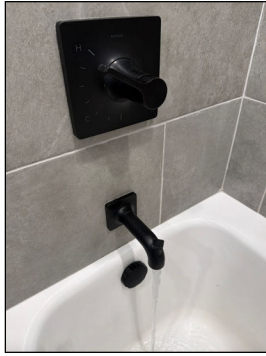
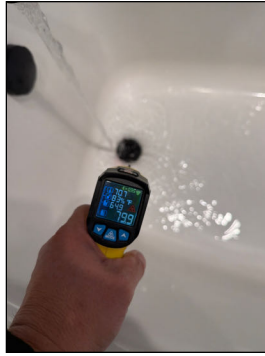
- Hot water present at all tub/shower(s) fixtures
- See individual photos of random temp checks for digital confirmation

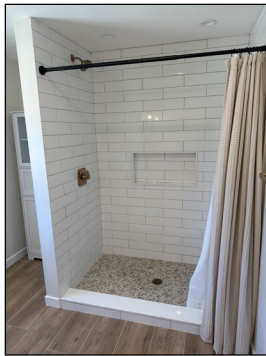
- No defects observed from shower enclosures, sliding doors, or tub enclosures

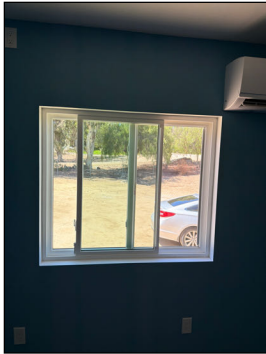
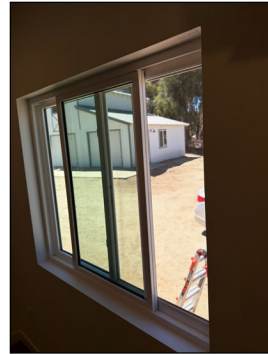
#### 4. Window(s)

- All windows tested are in correct working order with no defects at the time of inspections

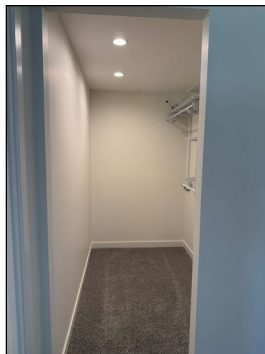
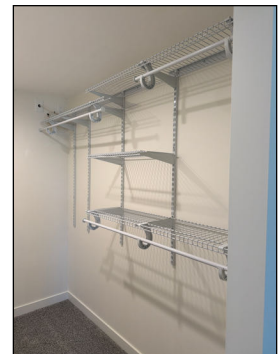
#### 5. Closets

- Closet did have electrical switch & light

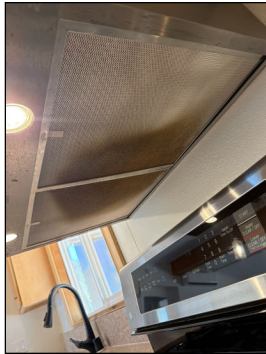
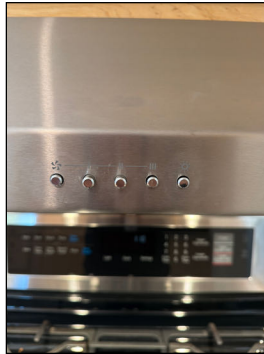
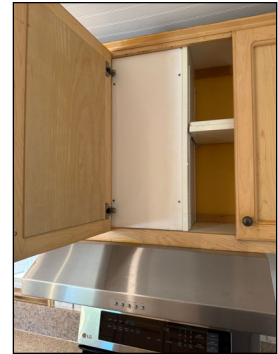
## 3. Exhaust Fan

- Vent fan/light operable when tested

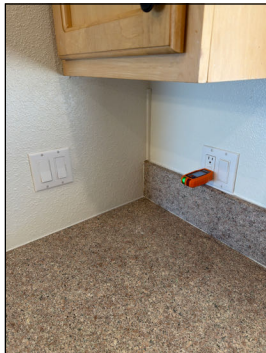
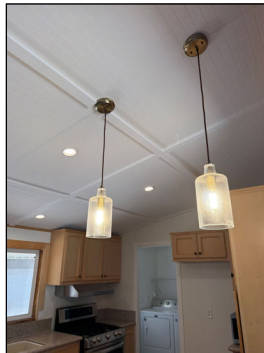
#### 4. Electrical

- SWITCHES\*\*\*
- Switches: Yes
- Switches, operable: Yes
- RECEPTACLES\*\*\*
- Receptacles: Yes
- Receptacles, operable: Yes
- LIGHTING\*\*\*
- Lights tested operational: Yes
- ---
- GFCI present: Yes
- GFCI operable: Yes

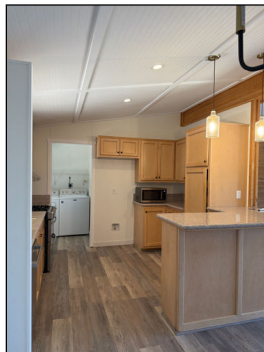
#### 5. Walls/Ceiling/Floor

- No visible defects or damage to any and all surfaces at the time of inspection
- Moisture Stains Present: No

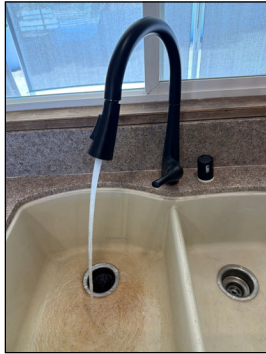
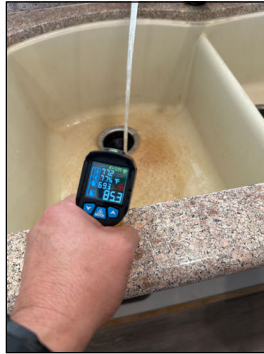
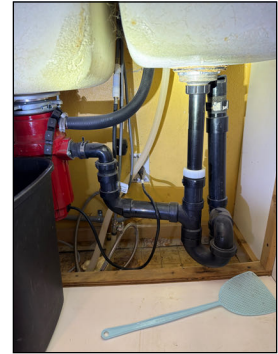
## 6. Plumbing

- Faucet leaks: No
- Pipes leak/corroded: No
- ---
- Functional drainage: Satisfactory
- Functional flow: Satisfactory

- No leaks or moisture stains noted restricted visibility due to personal items
- Hot water present at all sink fixtures
- See individual photos of random temp checks for digital confirmation

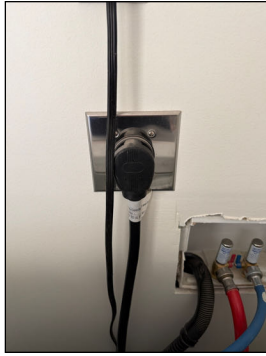
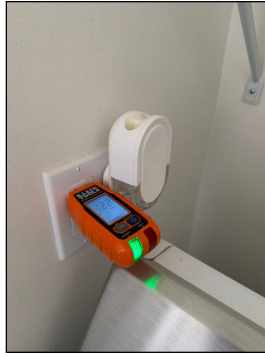
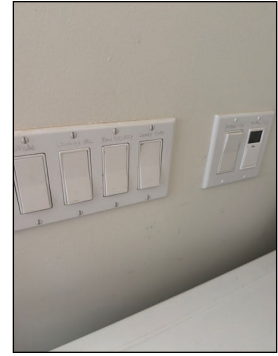
## 3. Electrical

- SWITCHES\*\*\*
- Switches: Yes
- Switches, operable: Yes
- RECEPTACLES\*\*\*
- Receptacles: Yes
- Receptacles, operable: Yes
- LIGHTING\*\*\*
- Lights tested operational: Yes
- ---
- GFCI present: Yes
- GFCI operable: Yes

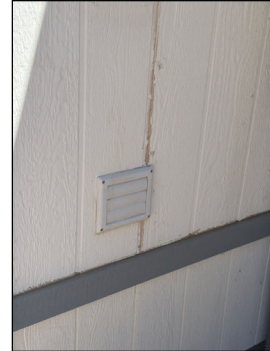
- Exhaust vent is flex and correctly directed to the exterior wall for ventilation

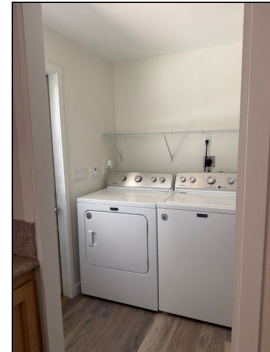
- No visible defects or damage to any and all surfaces at the time of inspection
- Moisture Stains Present: No

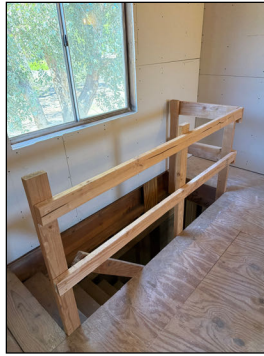
- Location: Garage
- Access: Stairs
- Stairs have a low headroom header mentioned to be aware of and use caution when using stairs

Low Header noted

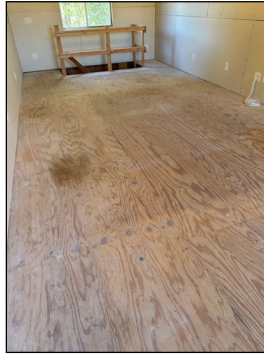
- Attic is conditioned walls/floors/ceilings have no visible defects or areas of concern

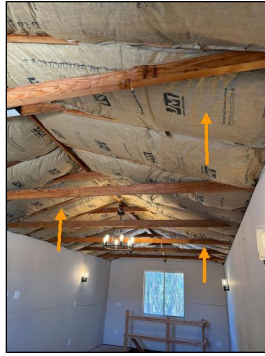
- Insulation Installed In: Rafters/Trusses

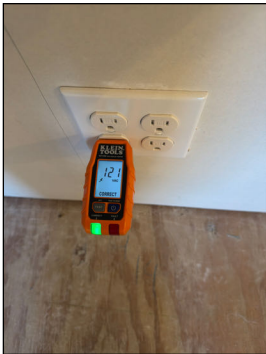
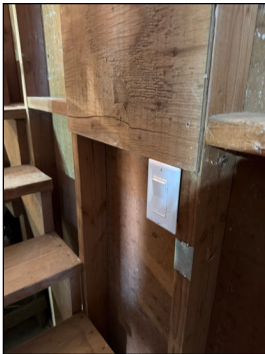
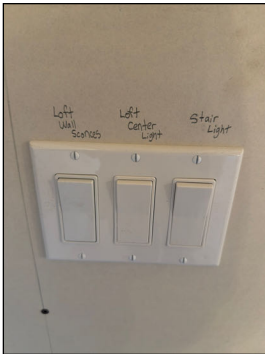
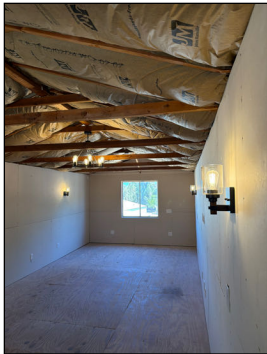
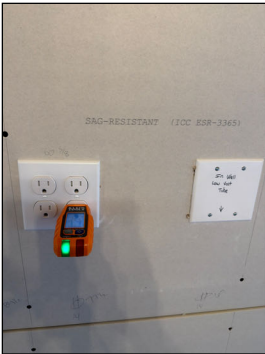
- SWITCHES\*\*\*
- Switches: Yes
- Switches, operable: Yes
- RECEPTACLES\*\*\*
- Receptacles: Yes
- Receptacles, operable: Yes
- LIGHTING\*\*\*
- Lights tested operational: Yes

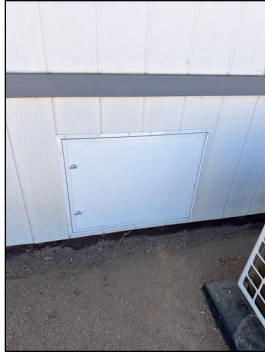
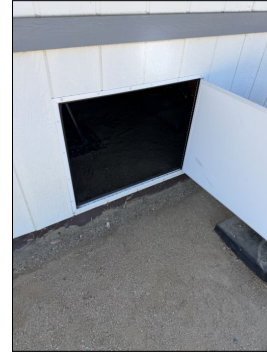
- Crawlspace Access Location: Exterior
- The access panel installed was functional during the inspection

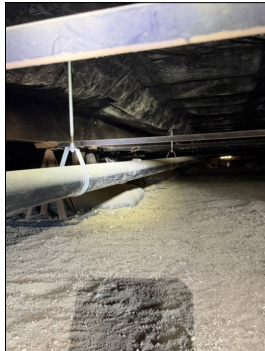
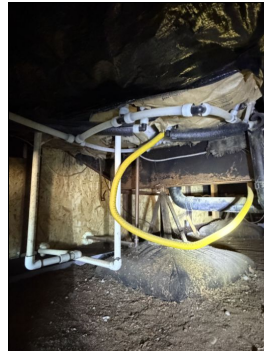
- General plumbing (Supply/Waste) observed appears functional and with no visible defects or damages
